MINE REHABILITATION CASE STUDY: DAWSON MINE

REHABILITATION OF HIGHWALL (PIT 18)

REHABILITATION OF SPOIL DUMP (PIT 25)

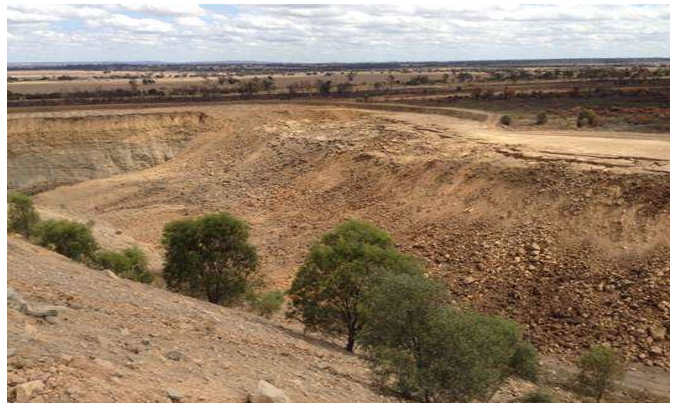
Pit 18: During rehabilitation process

At Anglo American's Dawson Mine, the company pioneered the use of blasting techniques to successfully reshape void highwall into final landform position in 2013.

Four blasts were required to complete the project, which moved considerable amounts of highwall material into final landform position. Following reshaping, the area was seeded with a grazing mix of native and introduced species. It was then treated with five tonnes per ha of Gypsum in 2017 and re-seeded.

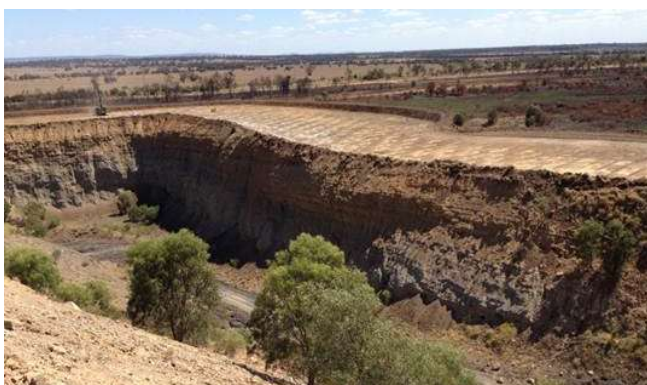
Pit 18: Prior to rehabilitation commencing

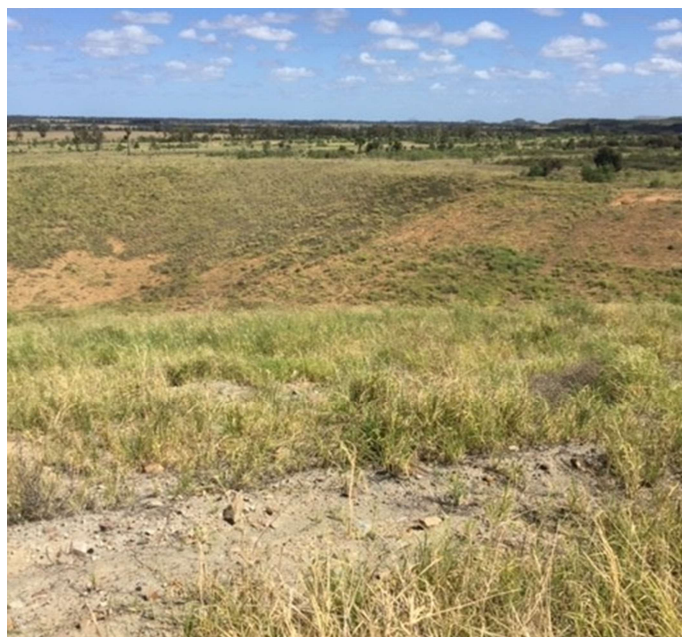
Pit 18: Site rehabilitation complete

The successful rehabilitation of the area has demonstrated the technique can be applied to reshaping mining voids – one of the most challenging aspects of rehabilitation for the industry – and rehabilitate land for productive post-mining use.

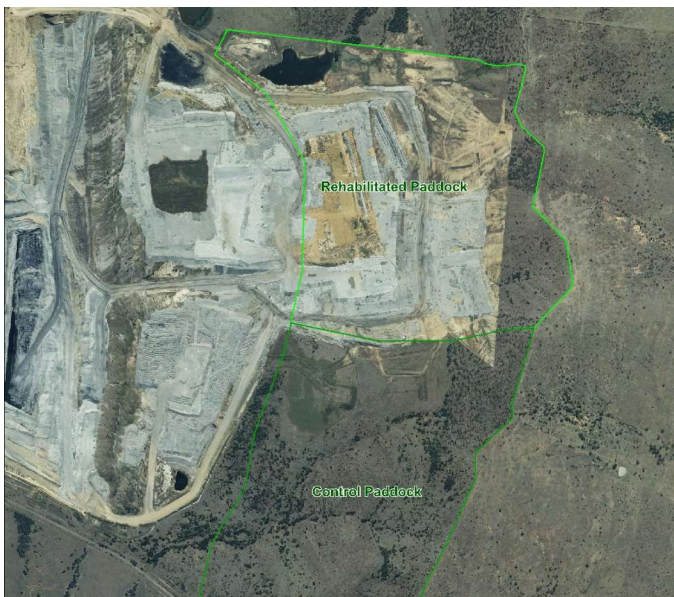
Pit 25: Prior to rehabilitation commencing (2011)

In 2012, the company's Dawson Mine commenced a rehabilitation project aimed at successfully establishing grazing activities on an area that had been previously used as a spoil dump and topsoil stockpile.

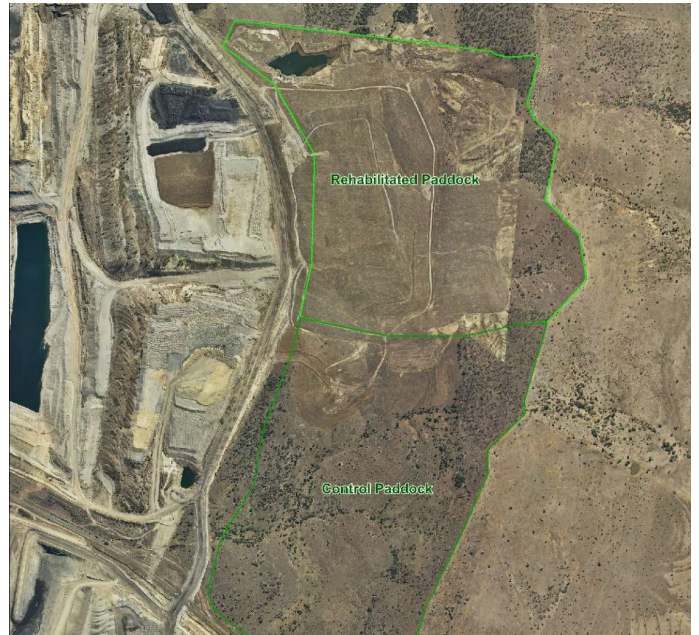
Pit 25: Rehabilitated area in 2014; good vegetation cover and no significant erosion

Mine spoil was pushed to a one in six gradient, and access tracks were added to the site. The rehabilitated area was landscaped, top soiled and then seeded.

Seeding occurred directly behind the dozer and included native pasture grasses such as Queensland Bluegrass and Curly Windmill Grass. Shrub and tree species were added to the seed mix including Brigalow, Silver-leaved Ironbark and bottle trees.

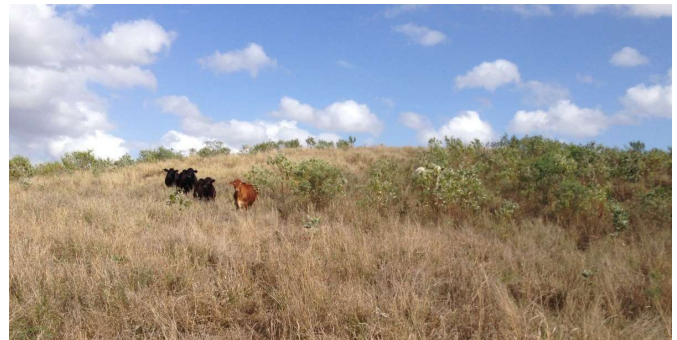
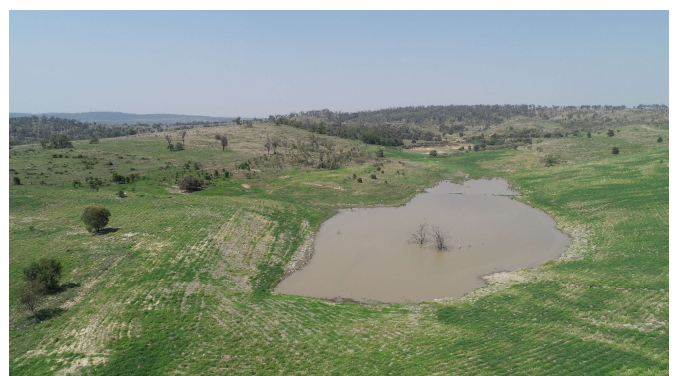
Pit 25: Cattle grazing still occurring sporadically (October 2018)

From July 2015, cattle weaners have been grazing in the rehabilitated paddock. The cattle were weighed twice in 2016 and demonstrated strong weight gain.
